Surface fatigue microcracks in turbocompressor blades of a turboshaft engine

J. Pavlas^{*a*,*}, M. Růžička^{*a*}, S. Slavík^{*a*}

^a Faculty of Mechanical Engineering, Czech Technical University in Prague, Technicka 4, 160 00 Prague, Czech Republic

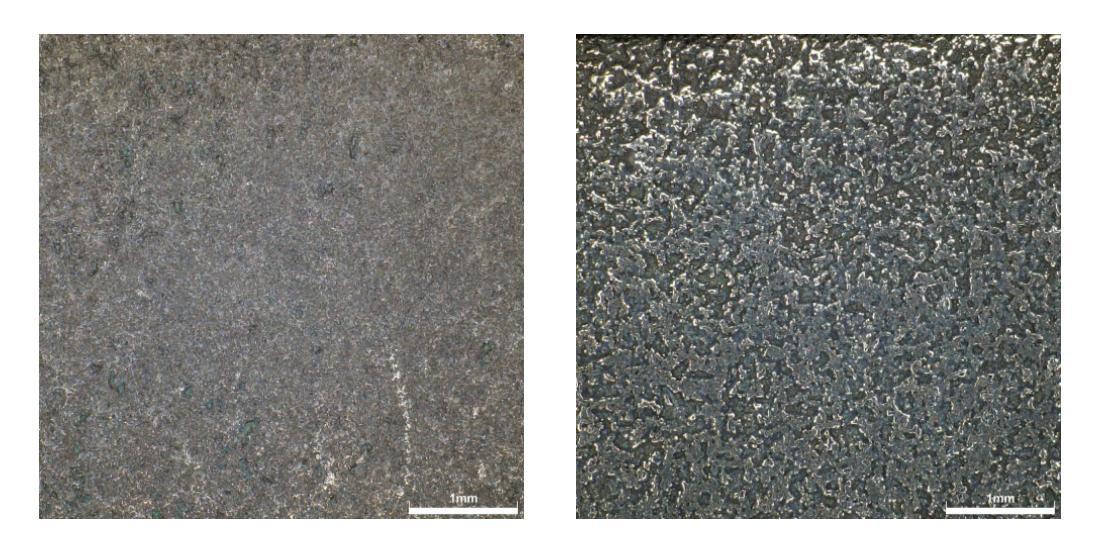
It has been found that some blade surfaces are seriously damaged during operating. The difference between the surface quality before and after the general overhaul is shown in detail in Fig. 3. The blade after the general overhaul (before operating) has very smooth surface with no major geometrical differences. The blade surface after the operation time between two overhauls is full of non-homogeneous crater-shaped areas. The usual depth of these craters is in the interval of $3-10 \,\mu\text{m}$ and their usual diameter is $10-20 \,\mu\text{m}$. In some places, these areas connect and form a larger area and the protective layer is missing.

Non-homogenous surface leads to material degradation, which can initiate first fatigue cracks. Several very short initial cracks were detected. The protective layer is seriously damaged. Short fatigue cracks initiated from the non-homogenous protective layer are penetrating

Fig. 3. Blade surface after general overhaul (before operation - left) and before next general overhaul (after operation - right)

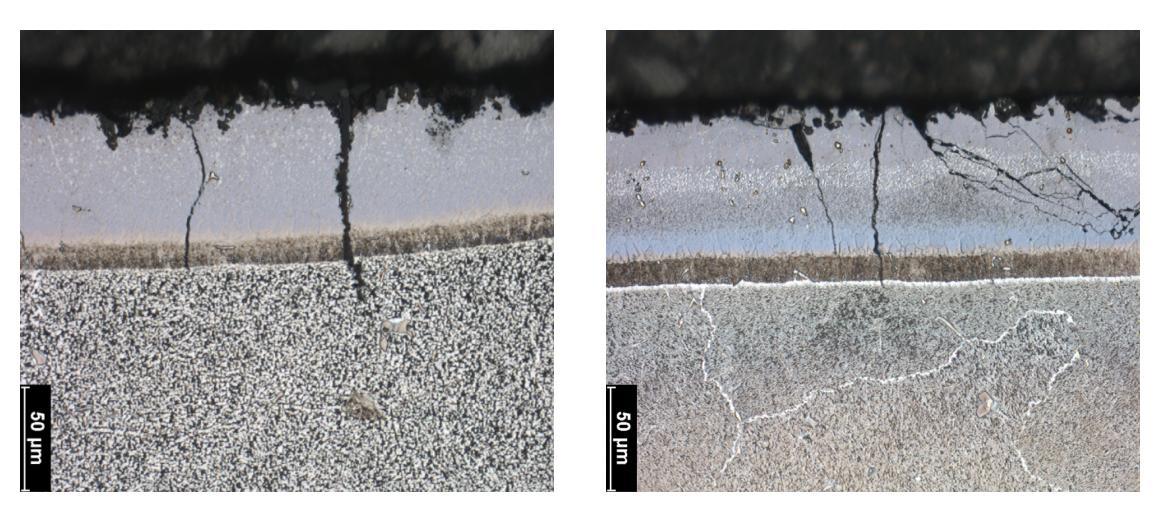
Fig. 4. Microcracks initiated in protective layer surface with the propagation to the substrate material

the substrate material. It is not possible to detect these defects during the operation or standard maintenance procedures requested by the design organization. Standard methods requested by the design organization must find fatigue cracks of the blade (without the protective layer) longer than 50 μ m. This crack length is much longer than the value of the found microcracks. These cracks can growth in the substrate material and cause blade destruction. The observed microcracks, Fig. 4, were initiated in porous area of the protective layer. The geometrical non-homogeneity forms the natural micro-notch with a stress concentration.

Another physical reason for the appearance of fatigue microcracks can be the roughness of the protective layer. Some fatigue microcracks appear at the location of surface geometric irregularities of the protective layer, Fig. 4. In some cases, these irregularities act as notches. Achieving a reduction in roughness is technologically very difficult.

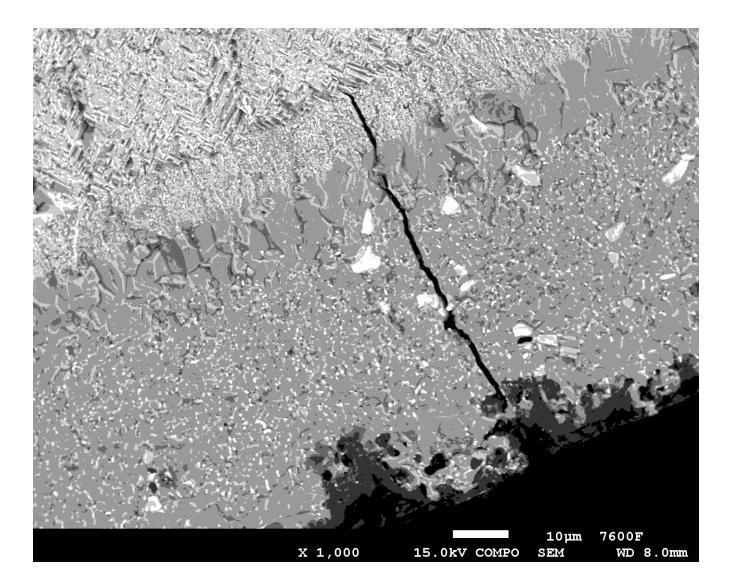
As shown in Fig. 5, the observed high temperature oxidation of the protective layer with combination of porosity caused the crack initiation. Also, the oxidated area is a natural notch with higher stress values during the operation.

Fig. 5. Microcracks initiated from the high temperature oxidated area

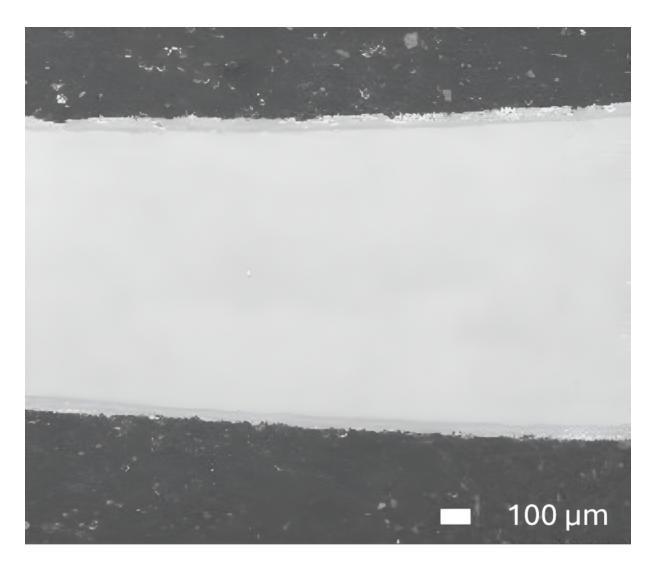
Fig. 6. Examples of a new non-homogenous protective layer

The purpose of the general overhaul is to restore the blade's protective layer to its original condition. The protective layer has a variable thickness, Fig. 6. The protective layer with unacceptably low thickness is not able to withstand hot gases and burns away. Then the substrate material degrades. The protective layer with unacceptably high thickness is also separates from the substrate material after only a few hours. These occurrences can cause high temperature oxidation process leading to material degradation, notches and first fatigue cracks, Fig. 7.

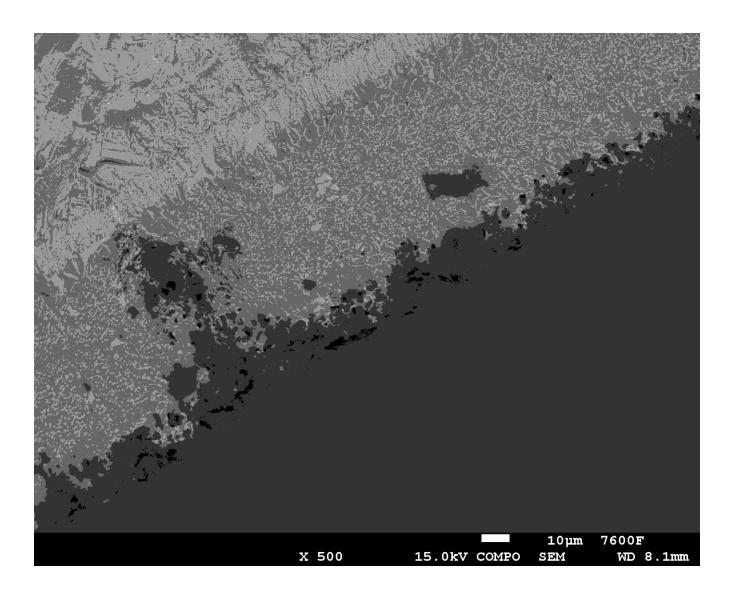
Fig. 7. Examples of the porosity leading to high temperature oxidation
